# Failures of Vibration Supervisory Systems for Turbine-Generator Sets

by Kim A. Lovejoy, President  
Lovejoy Controls Corporation

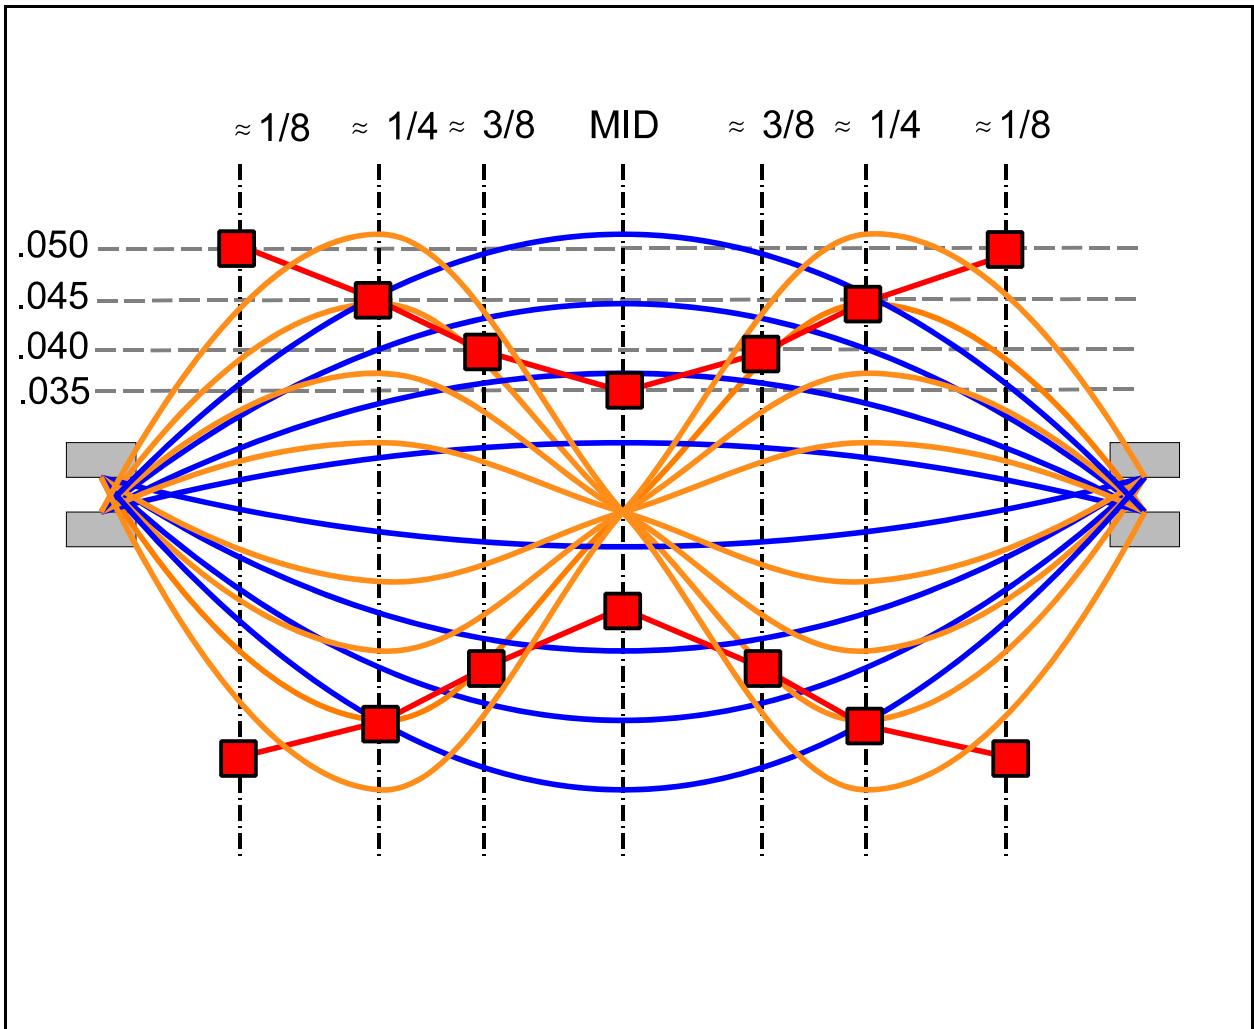
These clearances are plotted (red) on Figure 1 along with the first (blue) and second (orange), range of amplitude mode deflection curves. Several important observations are revealed in Figure 1:

- (1) If contact is to be avoided between rotating and stationary turbine elements (a good practice!), the deflection due to unbalance or rotor bow must not reach the clearance at any longitudinal position.
- (2) The relative deflection and therefore safe operating vibration levels of the rotor highly depend upon the modal shape of the deflection. For example, the mid-span .035-inch clearance is not even approached by the second mode at high amplitude but is easily exceeded by first mode at rather low amplitude.
- (3) Using the simplistic Rathbone severity of single-valued displacement alarm level is totally inadequate to warn of hard internal contact and turbine rotor damage.

For example, let's look at a typical nuclear low pressure steam turbine rotor which has a 1800 RPM running speed and very large and long-spanned journal bearings. This rotor is symmetrical, i.e. each longitudinal side of the rotor is identical and steam flows from the center out each end to the condenser below. The Spindle Clearance Drawing indicates that the seal clearances axially are set to the following at outage inspections:

Clearance at near mid-span:

.035 inch

Clearance at near 3/8-span:	.040 inch
Clearance at near 1/4-span:	.045 inch
Clearance at near 1/8-span:	.050 inch

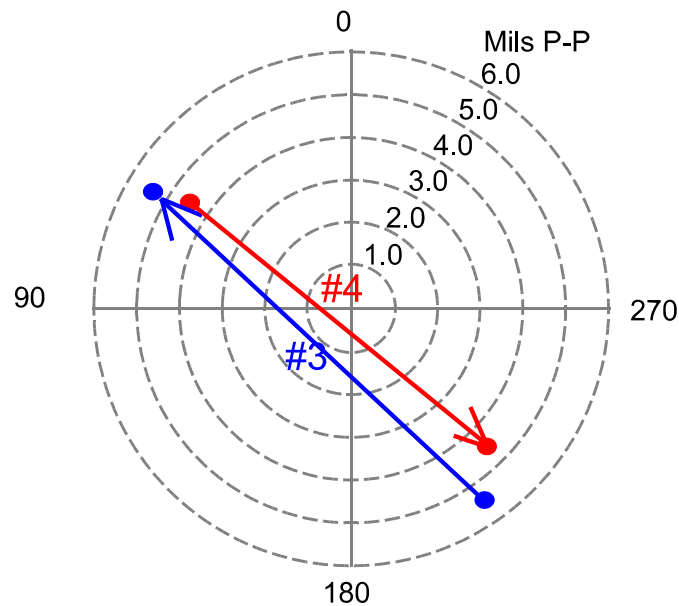
At this point it appeared that whatever happened, the turbine vibration levels slightly *decreased*, and therefore shouldn't be cause for concern. If we look at a polar vector plot of the data, however, the true magnitude of the event becomes clear.

Although the before and after vibration amplitudes (distance from plot center) didn't change much, the vector moves "crossed center" indicating a sudden and large change in rotating mass. The resulting inspection revealed the cause to be three lost shroud on the L-2 blade row, an event undetected by conventional monitoring even with amplitude envelope monitoring.

Bearing #4 4.4 mils @ 195 degrees referenced to exciter notch
